**RE: HUTCHINS STREET SQUARE COMMUNITY CENTER | POOL SHELL STRUCTURAL INVESTIGATION  
MEMORANDUM  
LODI, CA**

Siegfried Engineering visited the Hutchins Street Square Community Center located at 125 S. Hutchins Street in Lodi, CA on 03/05/2026. Staff had reported that following draining and refilling of the pool for maintenance purposes, multiple cracks in the structural concrete pool shell were leaking water into the storage/equipment room below. The purpose of our visit was to evaluate the accessible portions of the existing second-story pool shell in order to assess existing structural conditions and facilitate future repairs. The pool was partially drained at the time of our investigation.

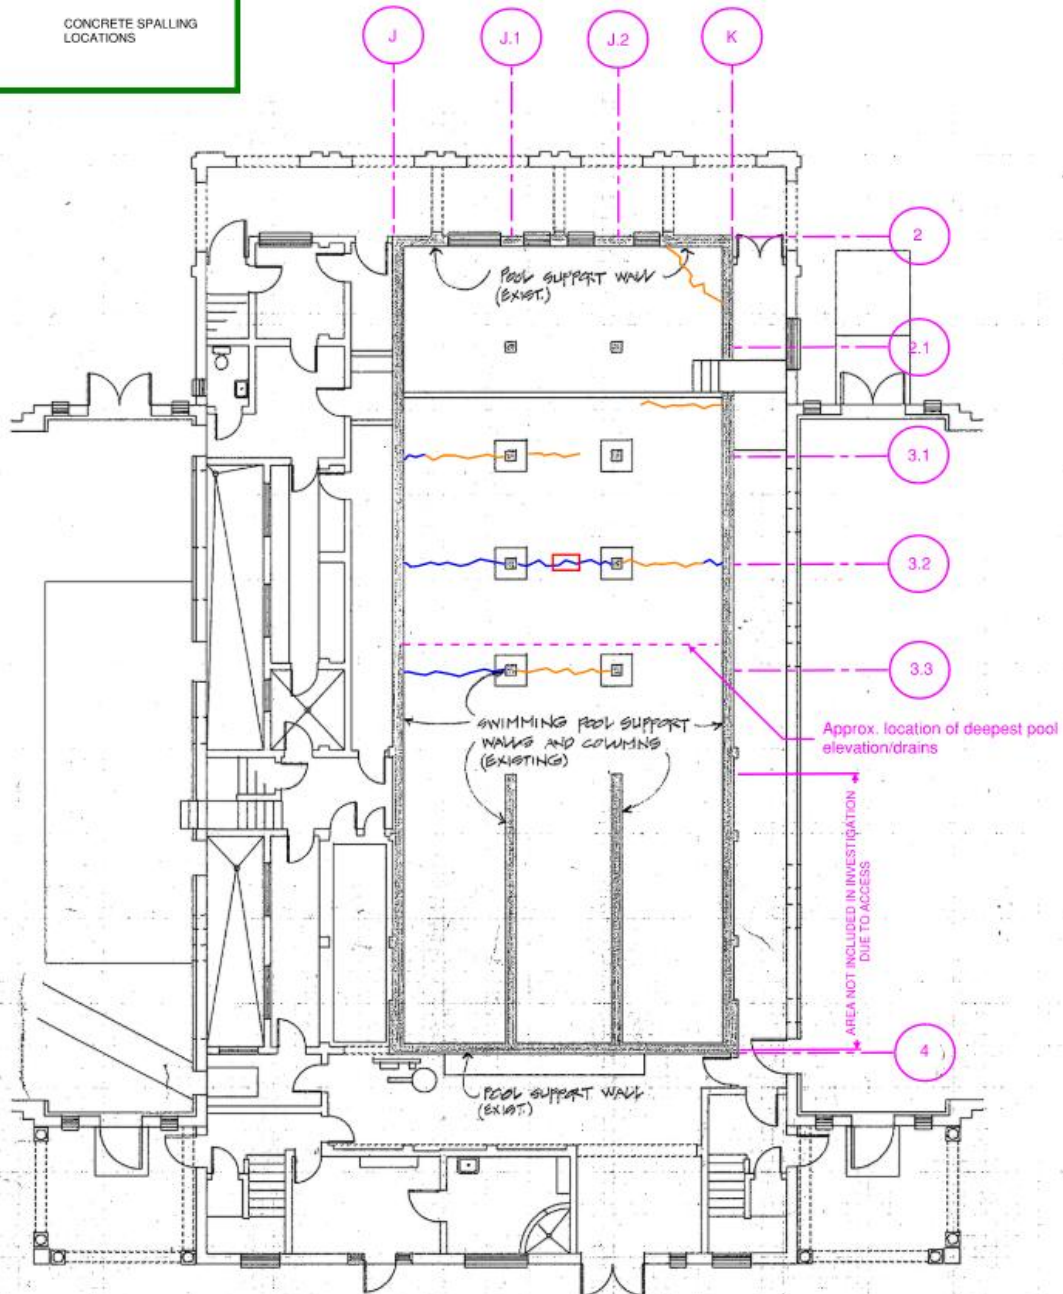
**FIGURE 1**

- Multiple transverse concrete cracks were found in the bottom of the accessible portions of the pool shell. These cracks typically ran north-south and were fairly evenly spaced at roughly ten-foot centers, often aligning with the supporting concrete column lines (See Figure 1). Cracks ranged from hairline cracks to 0.040” in width. Some cracks showed evidence of water intrusion during the time of our investigation (near the deep portion of the pool above, between lines 3.2 and 3.3) while others remained dry. **We did not observe any noticeable deflection of the pool shell at the crack locations, nor did we observe any differential movement between the concrete sections on each side of the cracks.**

While original construction documents were not available for review, we expect the pool shell to be a mild steel reinforced concrete slab six to eight inches thick. We did not observe any joints in the concrete shell. Based on the consistent spacing and alignment of the cracks, efflorescence deposits and lack of joints, the cracks in the concrete shell were likely existing prior to the recent pool maintenance and only made evident by the water intrusion reported by the staff.

2. Informal concrete sounding hammer tests were performed along the lengths of all visible cracks identified during our site investigation. We observed one area of concrete spalling, roughly 8 inches wide by one foot long near the crack located along line 3.2 between J.1 and J.2 (see Figure 1). **This area should be further exposed by a contractor and documented prior to patching/crack injection. Any exposed rebar should be cleaned of rust/debris and coated with a corrosion inhibitor prior to repair. The overhead patching mix used should be suitable for a wet and corrosive environment.**

**Although the cracks have likely been in the pool shell for a significant period of time, we recommend these cracks be repaired to improve the structural performance and longevity of the shell prior to the pool being refilled and occupied. We recommend the cracks be pressure epoxy injected to restore the structural section and prevent further degradation of concrete and steel reinforcing. A contractor specializing in concrete repair/restoration should be consulted to determine the best course of action regarding repair procedures. These procedures include access, pasting of the cracks in preparation for injection and product compatibility with a wet environment and pool treatment chemicals involved. We do not recommend a limited, non-structural, waterproofing of the cracks from below the shell. Surface sealing the cracks, without first performing the structural repair noted above, would likely trap moisture within the section, leading to further damage of the steel reinforcing and possible loss of flexural slab capacity.**

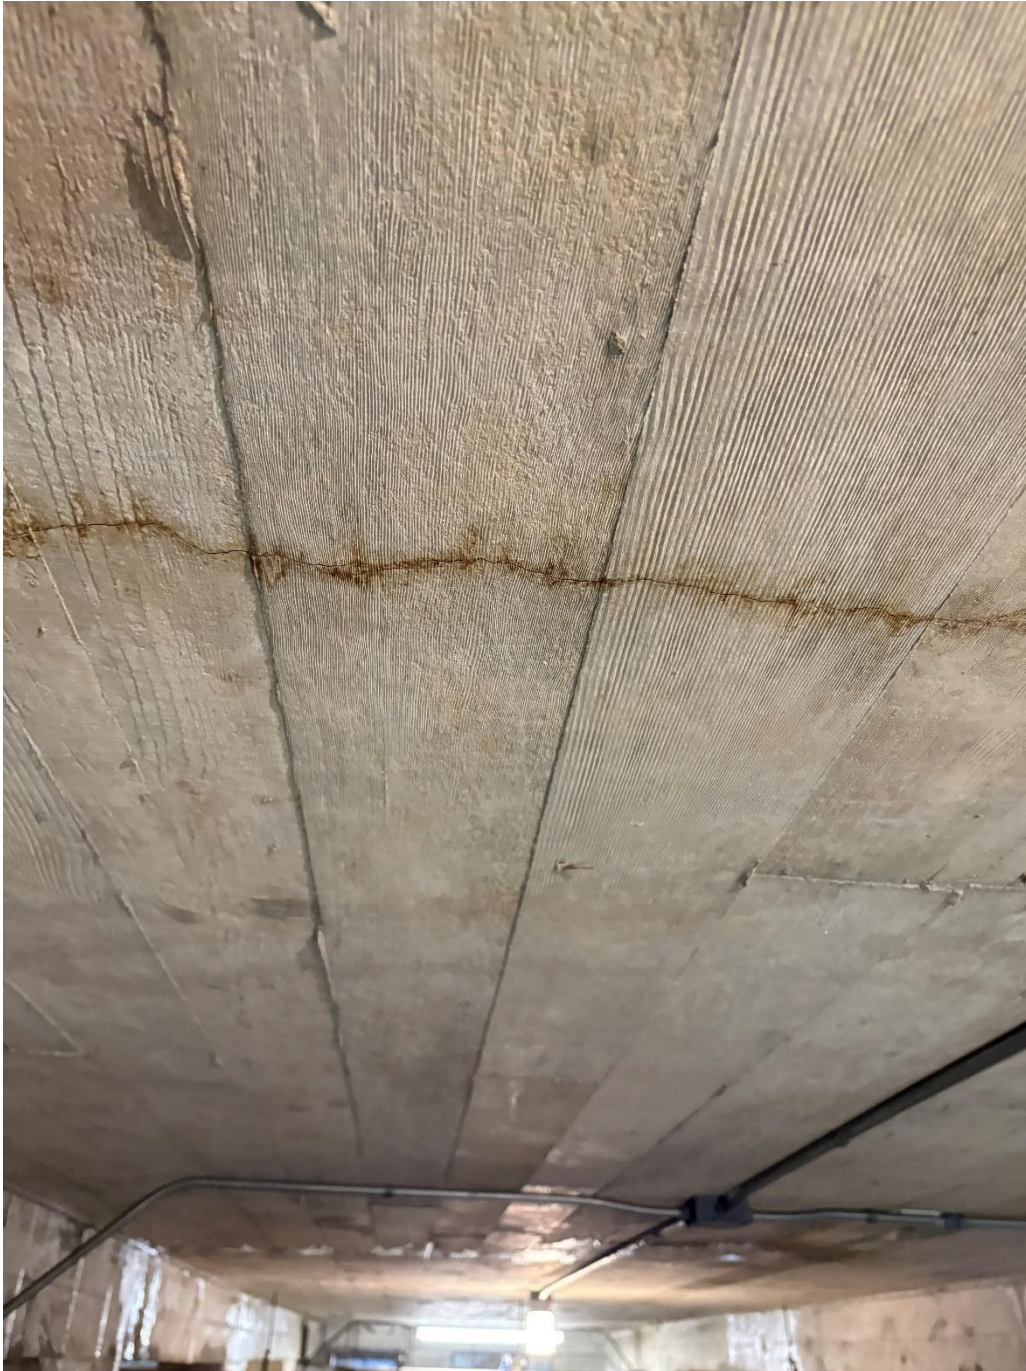
*Photo 1 – Transverse cracking in concrete pool shell*

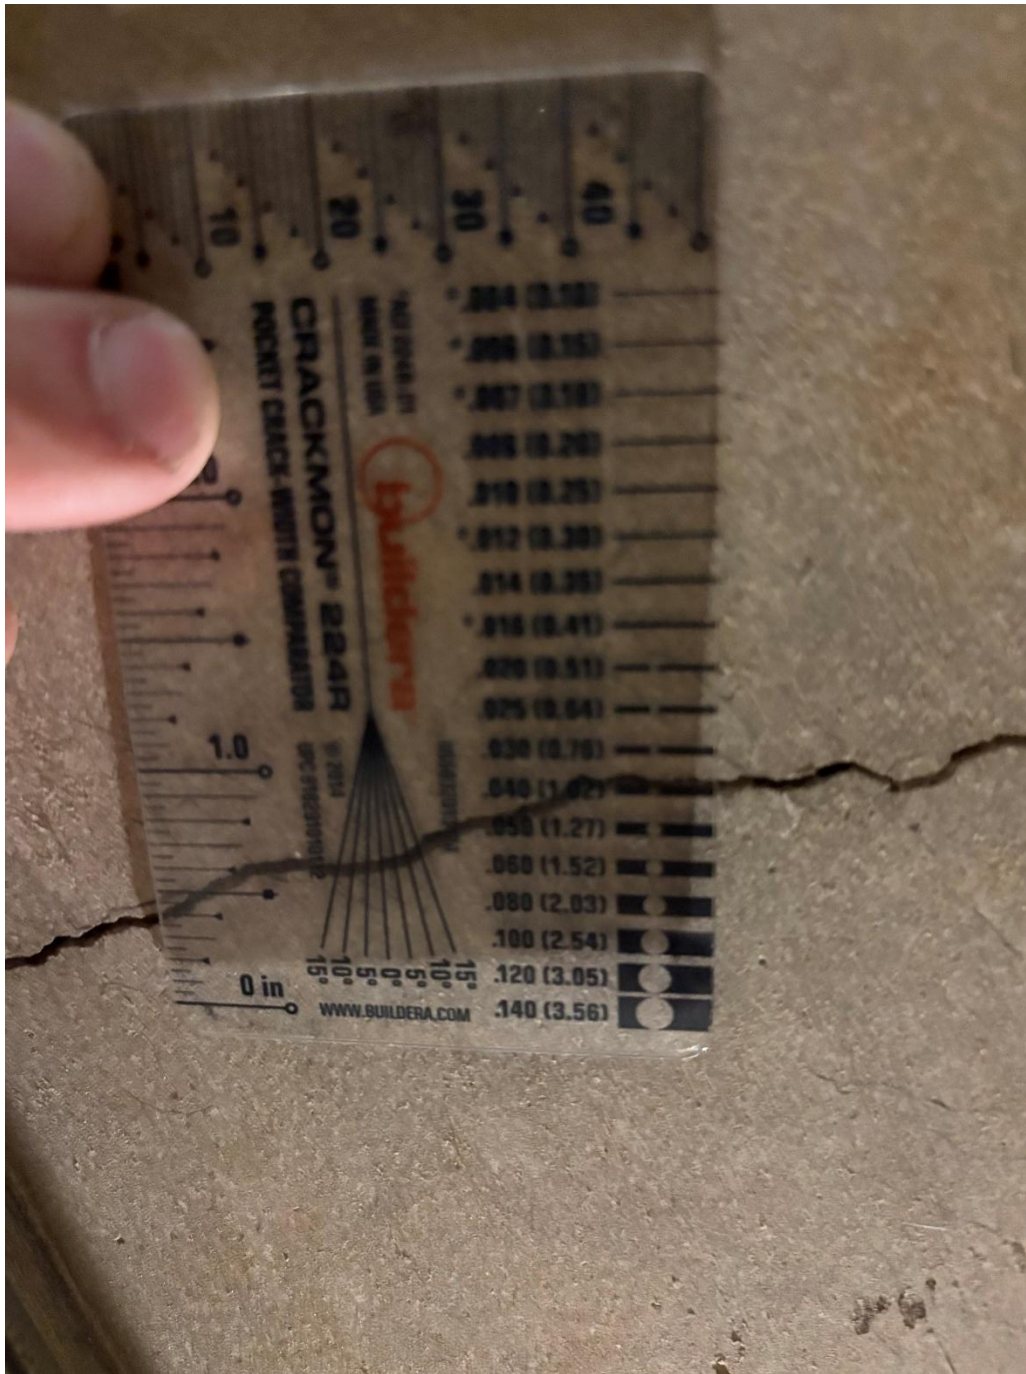
*Photo 2 – Cracking in concrete pool shell*

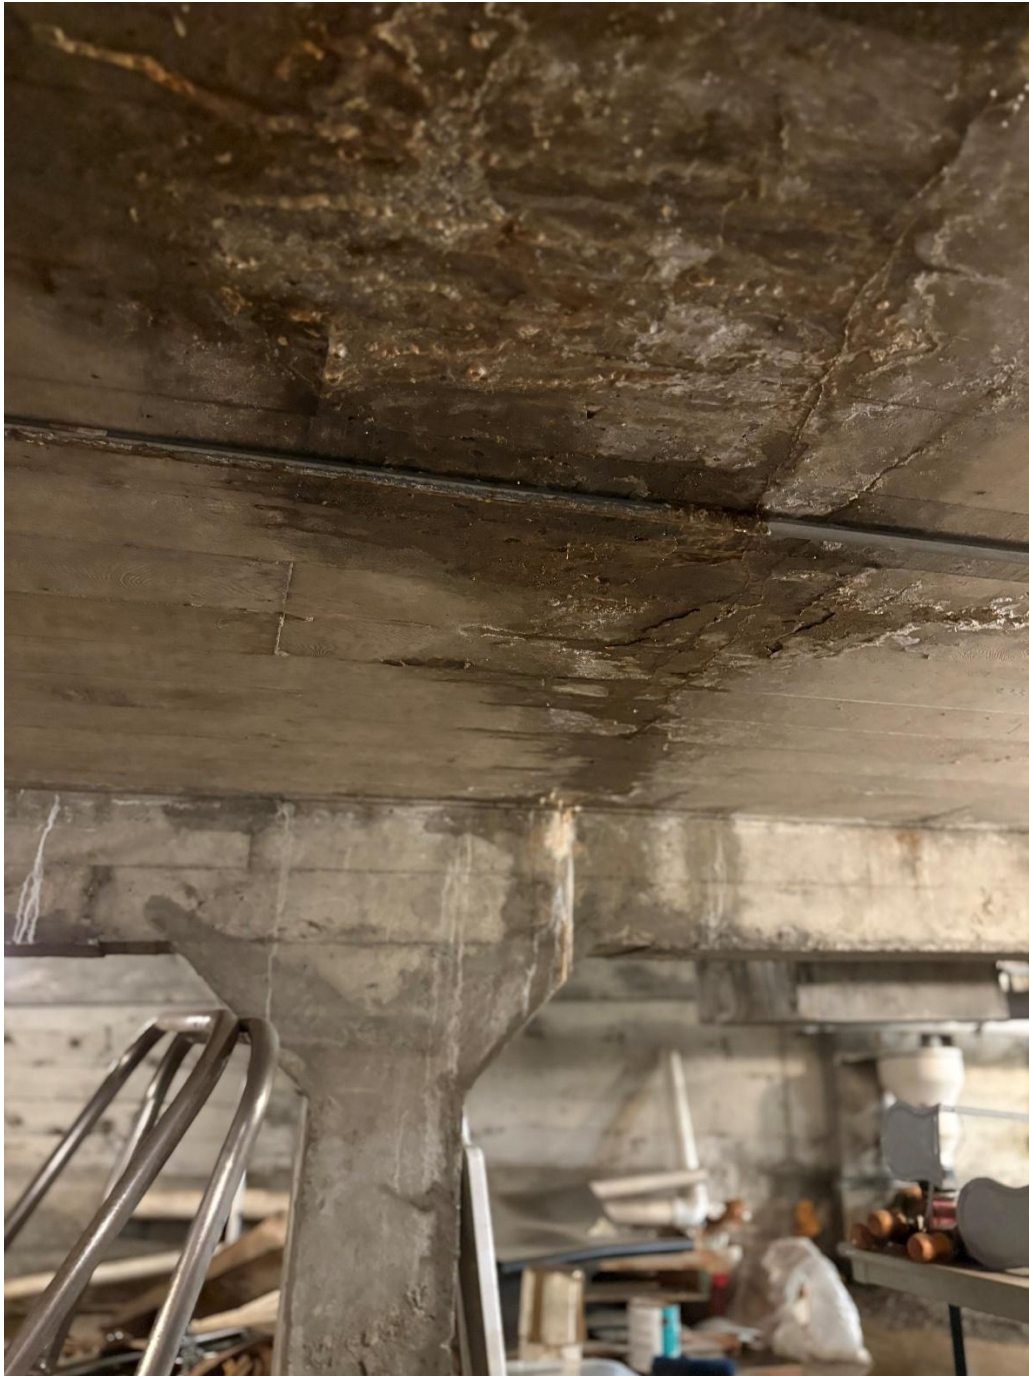
It is likely that there is a leak in the fiberglass pool coating or plumbing penetrations, causing water to seep through the cracks at the deeper parts of the pool shell. **We recommend the fiberglass pool coating and**

*Photo 3 – Cracking in concrete pool shell with water intrusion*

penetrations be investigated and any leaks sealed/repared prior to any structural repairs being performed.

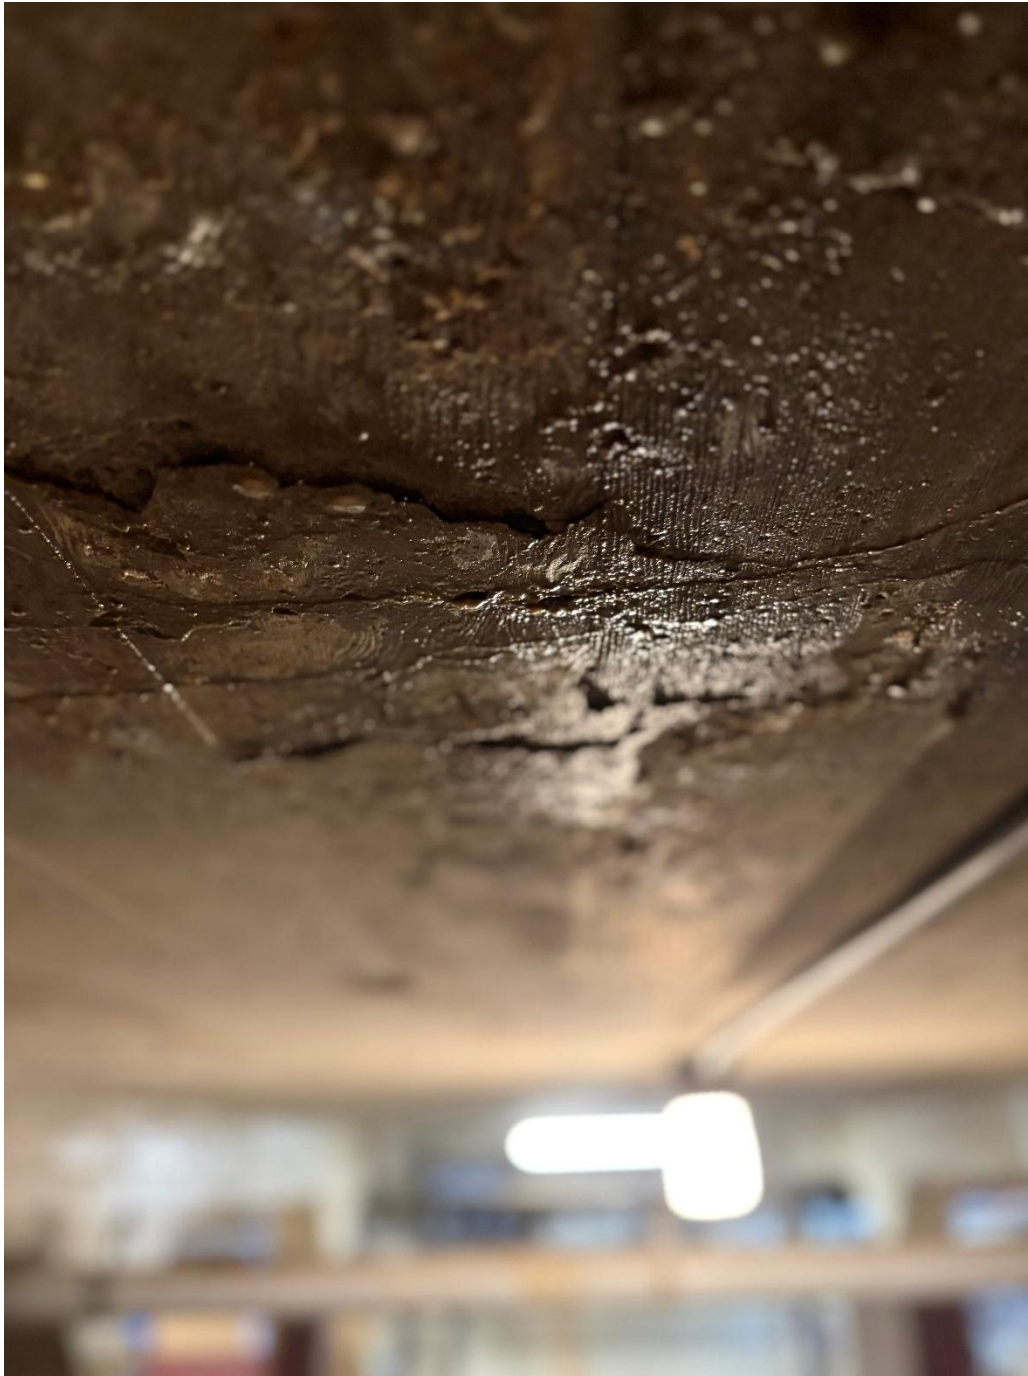
*Photo 4 – Concrete spalling along line 3.2*

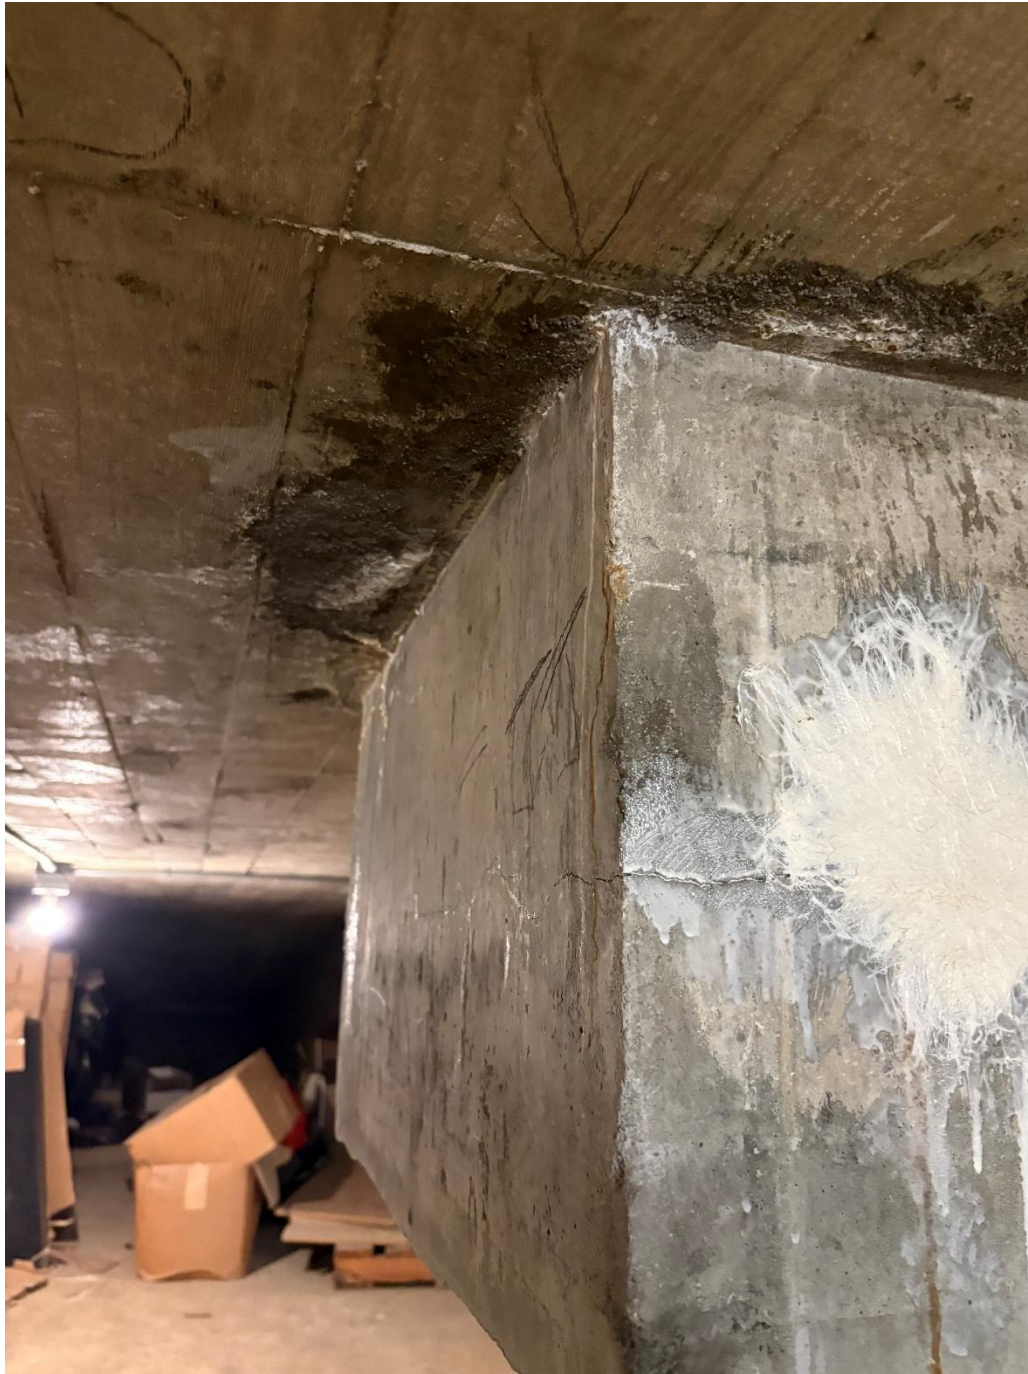
3. Drain boxes also showed signs of minor concrete cracking, water seepage and possible previous repair attempts. These cracks are likely concrete drying shrinkage cracks and appear nonstructural in nature. These should be sealed with epoxy injection methods similar to those in Item #1 above or a non-pressurized concrete sealing product suitable for vertical/overhead surface applications.

*Photo 5 – Concrete drain box*
